THOMAS HILL RESERVOIR DAM
RANDOLPH COUNTY, MISSOURI
MO 10134

**PHASE 1 INSPECTION REPORT
NATIONAL DAM SAFETY PROGRAM**

PREPARED BY: U.S. ARMY ENGINEER DISTRICT, ST. LOUIS

MAY, 1980

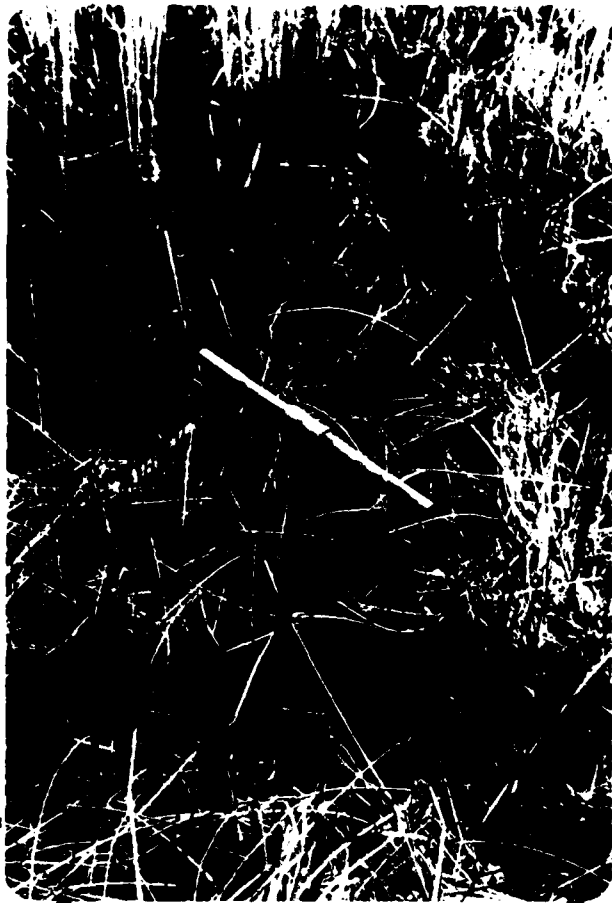
Photos 7 and 8 show seep in the left abutment. Photos 17, 18, and 20 show seep in right abutment trough. Photos 11, 12, 13 show relief wells and discharges. Photos 9 and 10 show water standing along toe of the berm and total discharge from the left end of the toe of the berm.

PHOTO NO. 8 - SEEPAGE DIS-
CHARGE AT OUTLET END OF
LEFT ABUTMENT

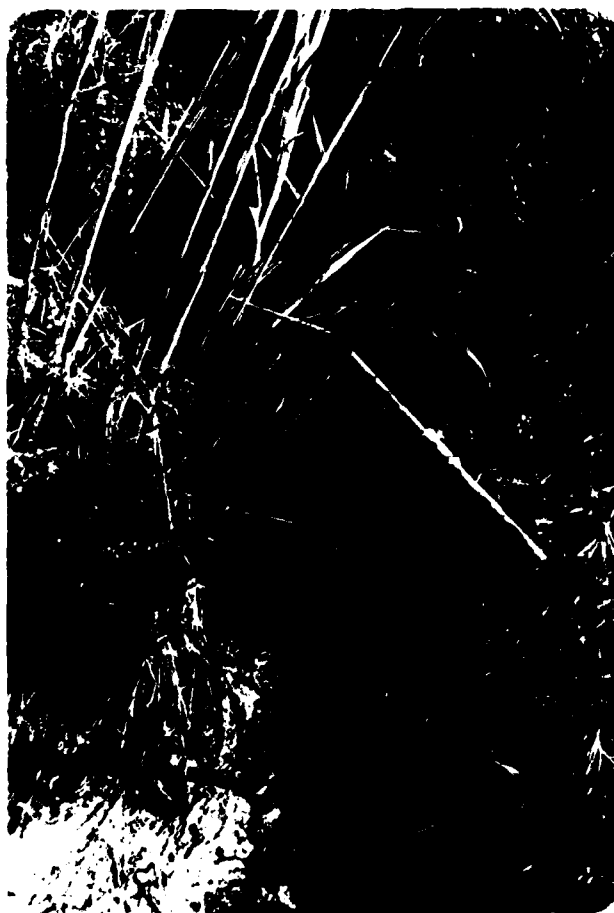
PHOTO NO. 11 - DISCHARGE
FROM LEFT RELIEF WELL

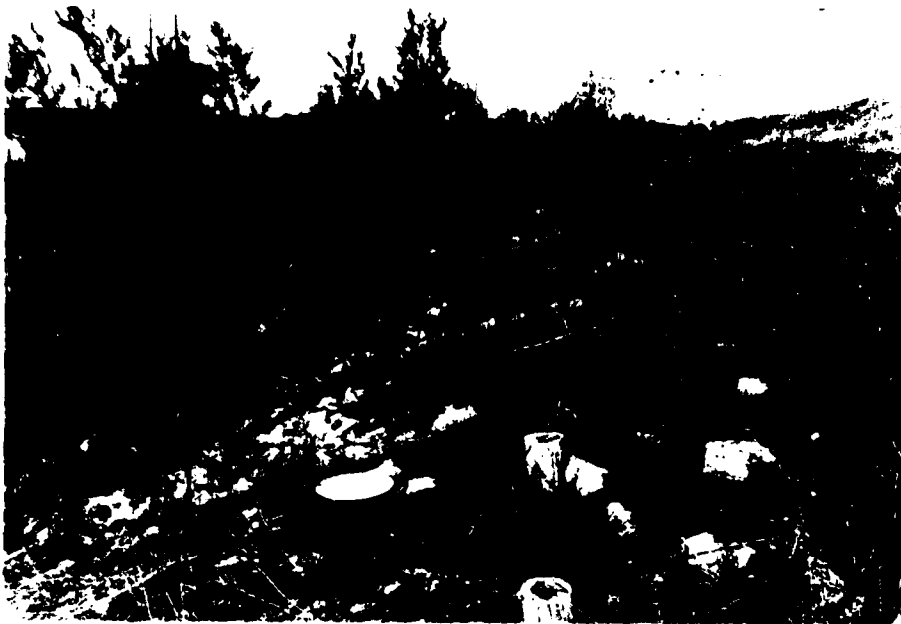
PHOTO NO. 12 - LEFT RELIEF WELL IN FOREGROUND

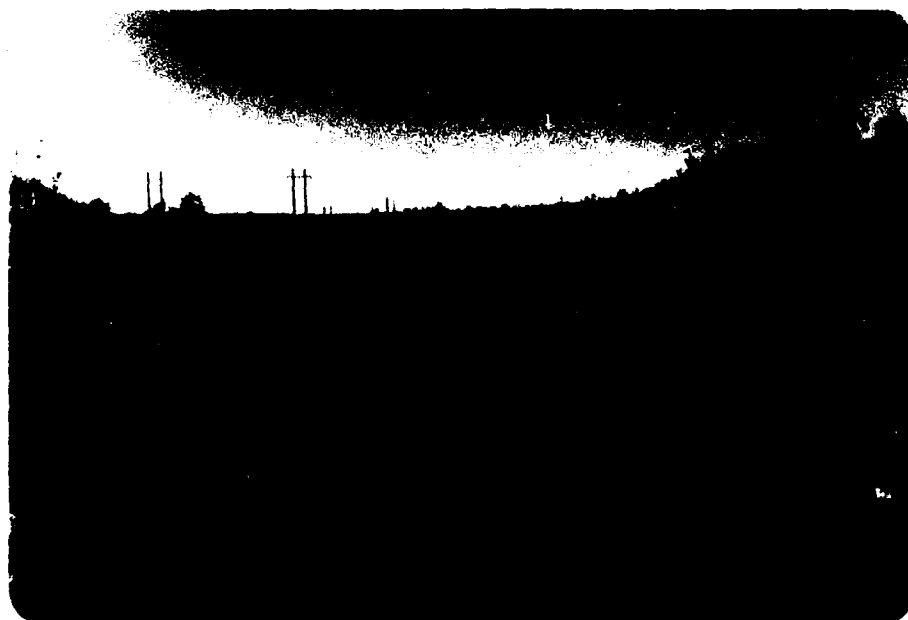
PHOTO NO. 17 - SEEP IN RIGHT ABUTMENT TROUGH

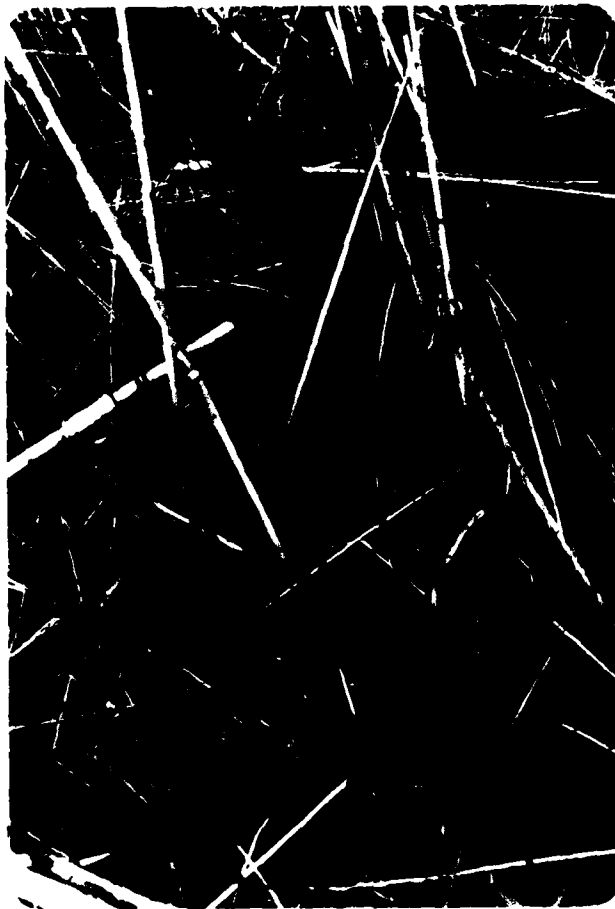
PHOTO NO. 18 - DISCHARGE
FROM SEEP AREA TO RIGHT
OF RIGHT ABUTMENT TROUGH

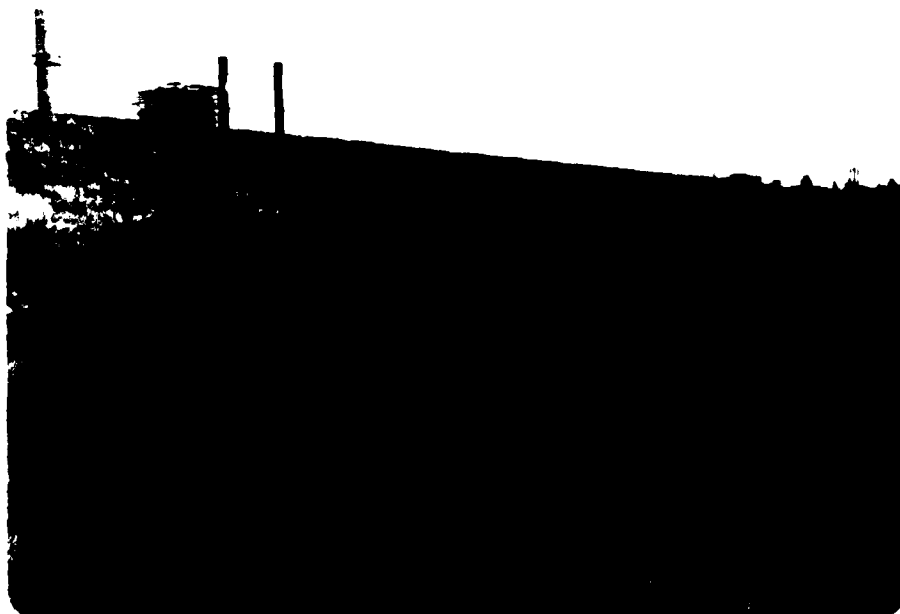
- (4) Downstream Slope. The downstream slope is well vegetated with adapted grasses. A few small trees are growing on the slope and berm. No cracks, deformations or rodent activity were observed on the slope or berm. The toe slope of the berm is well covered with riprap. The downstream slope is shown in Photos 5, 19 and 37.

PHOTO NO. 19 - DOWNSTREAM SLOPE FROM RIGHT SHOWING ROCK
COVERING TOE OF BERM

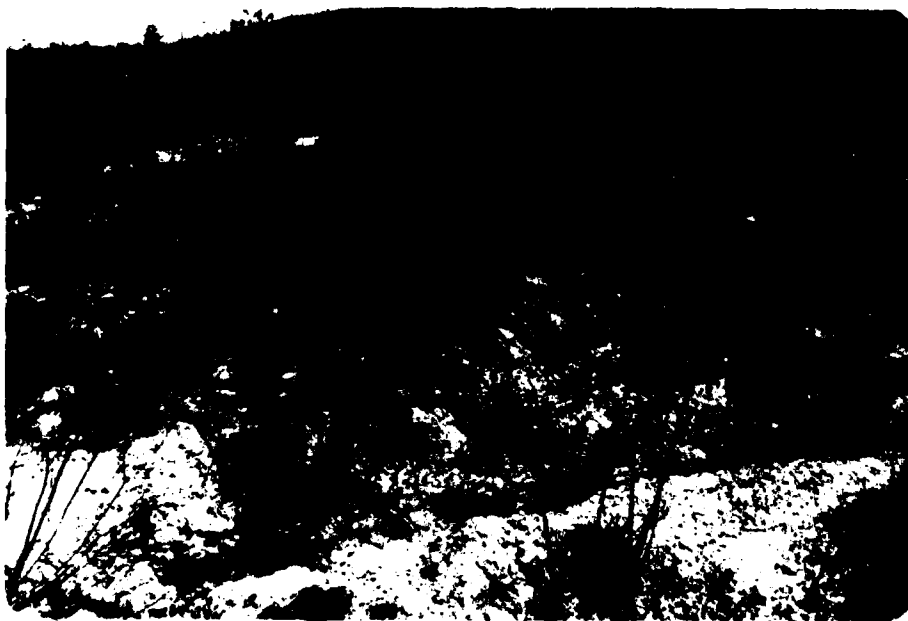
- b. Dam.
 - (1) Geology and Soils (Abutment and embankment). The dam is located in the dissected till plains overlying Pennsylvanian limestone and shale. The abutments consist of 5 to 10 feet of clay till overlying silty/clayey shales and clayey sandstones. Photos 6 and 21 show the shale outcrops in the abutments. The valley section consists of alluvial clays, silts and sand-gravel deposits up to 40 feet in depth. Materials in the embankment consist of CL-CH soils borrowed from the reservoir area and the upstream right abutment.

PHOTO NO. 21 - WEATHERED SILTY SHALE IN RIGHT ABUTMENT

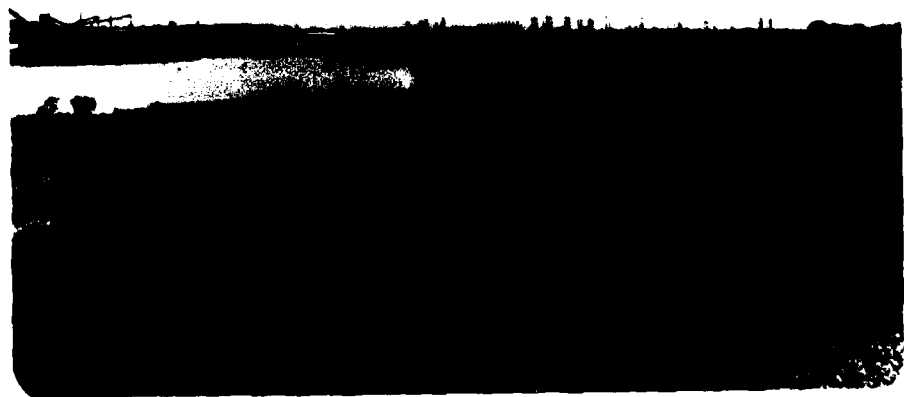
- (2) Upstream Slope. The upstream slope is well covered with good durable riprap consisting of limestone and quartzitic sandstone. Nominal size of the riprap was estimated at 24 to 30 inches. A few of the larger rocks (less than 5% of the total) showed signs of cracking and deterioration, but the riprap generally looked good. Measurements of the slope do not exactly conform with the plans; however, the measured overall slope is essentially equal to the planned compound slope. No obvious deformations were observed on the slope. Photos 3, 23, 30 and 31 show the upstream slope.

PHOTO NO. 23 - UPSTREAM SLOPE FROM RIGHT END

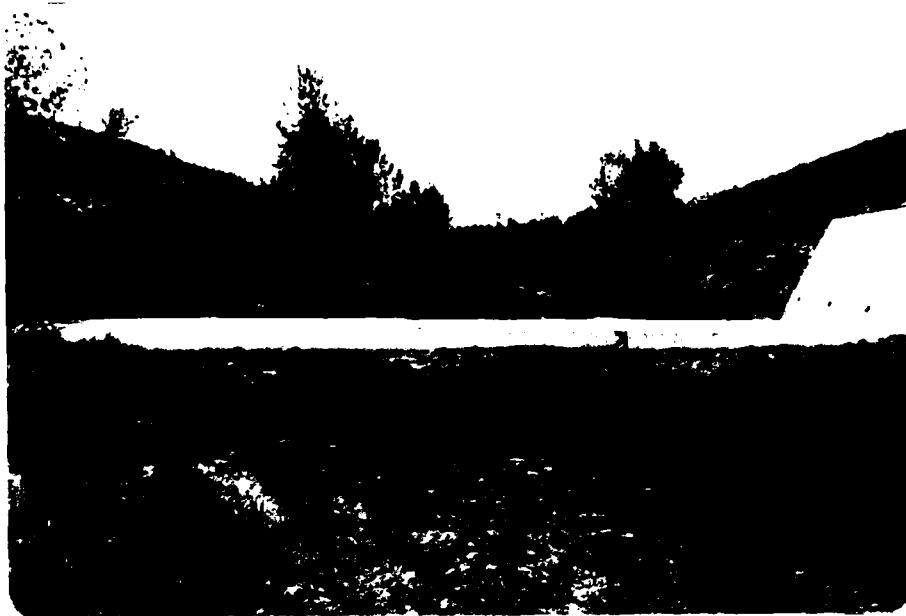
- (4) The spillway control section (ogee crest) appeared to be in excellent condition. (See Photos 25 and 26.)
- d. Overtopping Potential. The spillways will pass the probable maximum flood without overtopping the dam. The results of the routings through the dam are tabulated in regards to the following conditions:

PHOTO NO. 26 - VIEW DOWNSTREAM IN EMERGENCY SPILLWAY

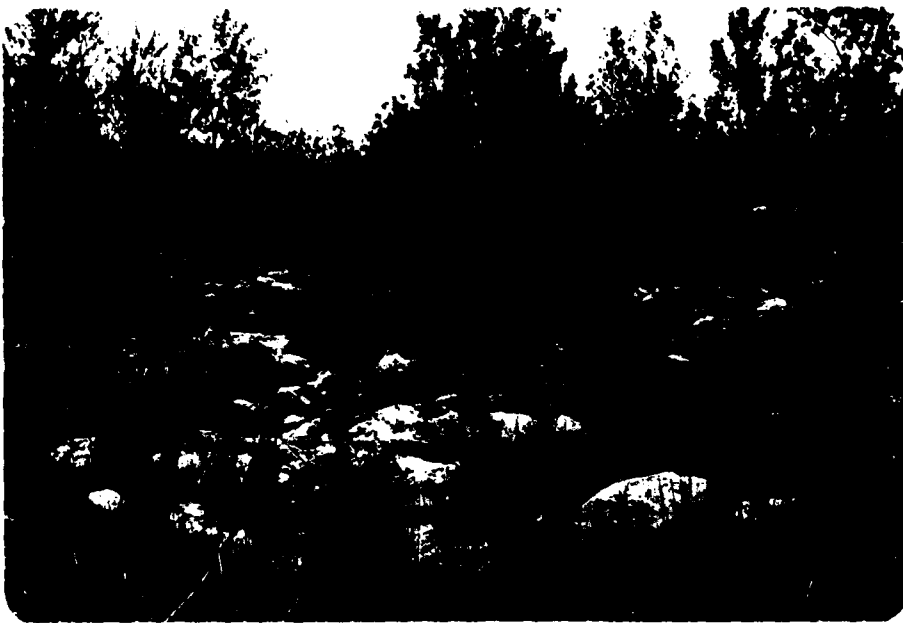
- (2) The emergency spillway consists of a 50 feet + wide channel excavated through bedrock (limestone and shale) in the right abutment. The control section consists of a reinforced concrete sill and ogee weir located across the spillway bottom on the centerline of the dam. The ogee weir control section was constructed in 1978 in accordance with plans shown on Plate C-20. The spillway has never operated. The concrete control section appeared to be excellent condition. Photos 24, 25, 26 and 27 show the spillway approach section, control weir and portions of the outlet channel. The outlet channel has a few trees growing along both sides as shown in Photos 26 and 27. The exit channel, some 400 feet downstream from the control section, has a number of trees (up to 6-inch diameter) growing in the bottom of the channel as shown in Photos 28 and 29.

- (3) The emergency spillway is located in the right abutment and is cut into bedrock. It appeared to be in good condition with the side slopes being riprapped above the limestone outcroppings. There were, however, a few trees located in the exit channel. Spillway releases will not endanger the integrity of the dam. (See Photos 28 and 29).

PHOTO NO. 28 - EXIT CHANNEL FROM SPILLWAY

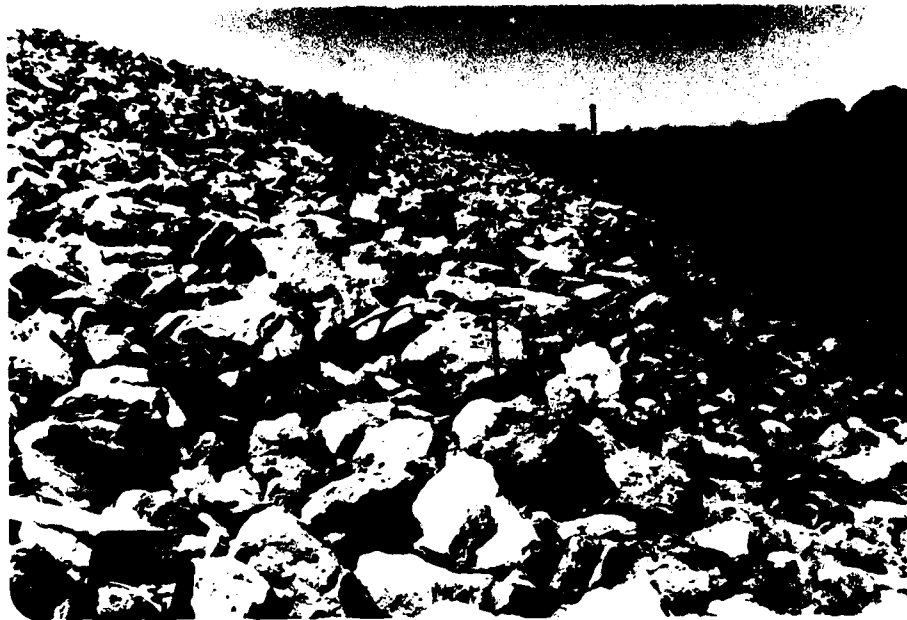
PHOTO NO. 30 - UPSTREAM FACE TAKEN ABOUT CENTERLINE LOOKING
TO RIGHT

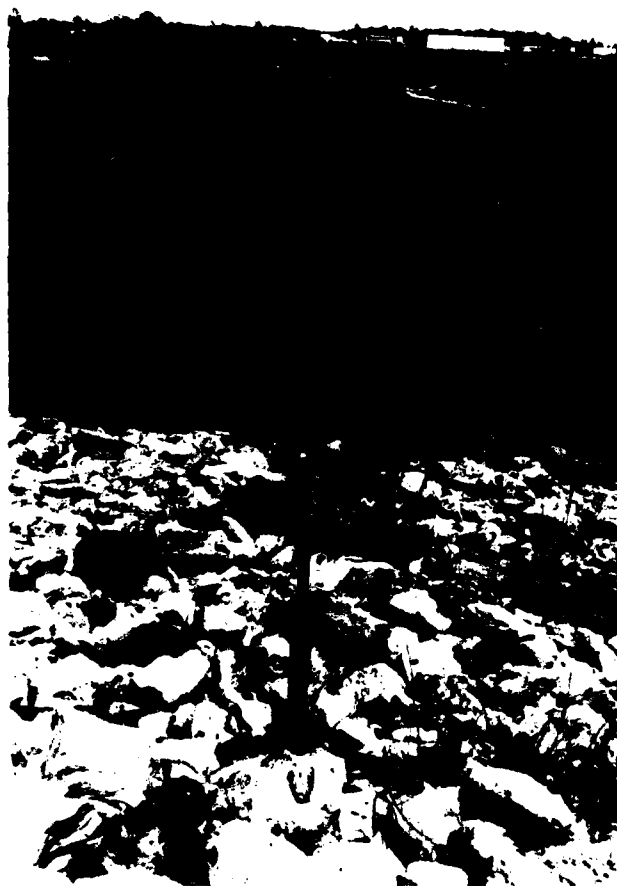
PHOTO NO. 31 - SETTLE-
MENT GAUGE NO. 1 AT
STATION 27+50±

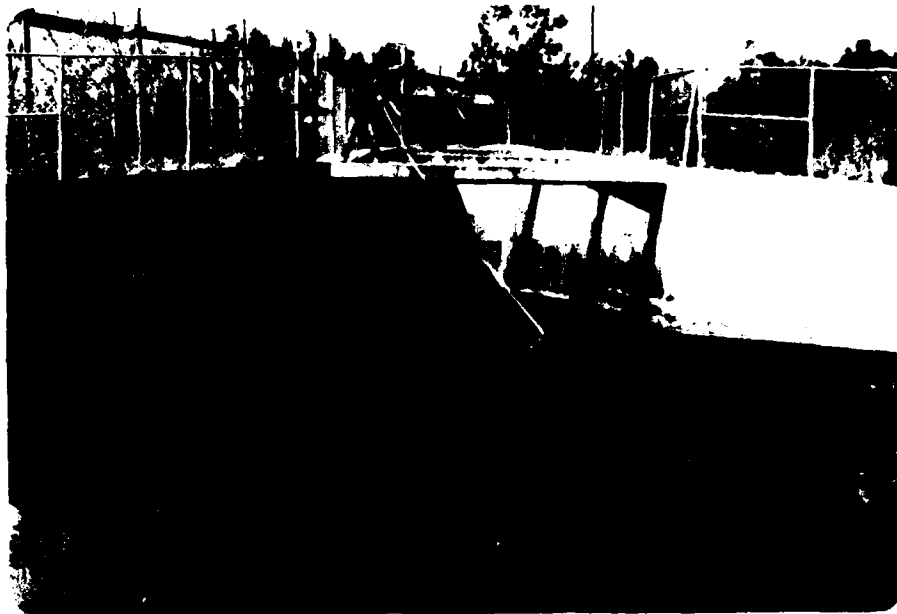
- (2) The stilling basin and exit channel appeared to be in good condition. The exit channel was straight and uniform and was clear of debris and weeds. (See Photos 34, 35 and 36)

PHOTO NO. 34 - VIEW OF PRINCIPAL SPILLWAY OUTLET

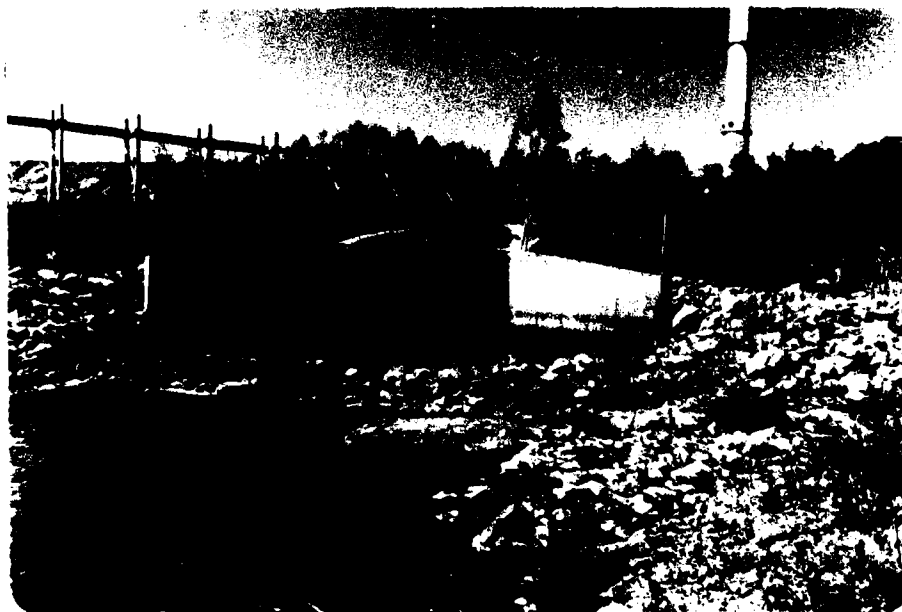
PHOTO NO. 35 - OUTLET OF PRINCIPAL SPILLWAY FROM DOWNSTREAM
